PRUSA edition heat break clogging analysis

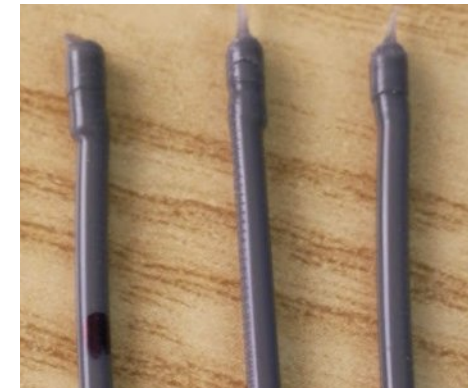
4. Once started, this event triggers a chain process where the more filament resistance is encountered the more it expands laterally and up (it is more and more difficult for the extruder fit the soft part into the bottleneck lower 2.0 mm hole bottleneck channel) . This status is visible during the print, since on the bed you can see that your print is starting to under extrude.

How you see that the filament blob has been created (under extrusion)

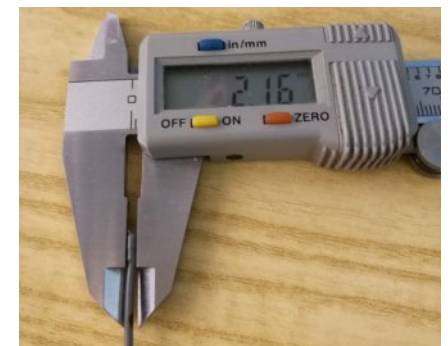
Several samples of filament blobs

Filament clog diameter is almost the same of the internal 2.2 mm heat break
